PERMEABILITY OF RAINGARDENS – FIELD MEASUREMENTS AND OBSERVATIONS IN AUCKLAND

*R.B. Roelofs (Author), MSc Student Environmental Engineering, Aalborg (DK) -
Urban Aquatic Environments Trainee, NIWA, Auckland*

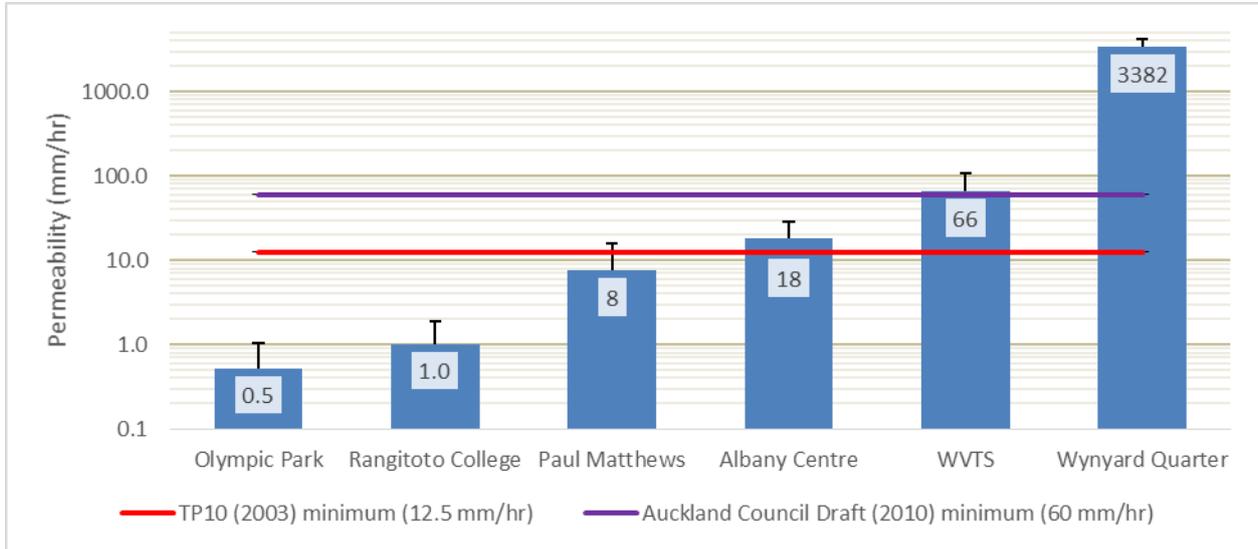
Figure 1: Permeability derived from infiltration, error bars indicate standard deviation

The results in Figure 1 show that three out of the six assessed BRCs had a mean permeability exceeding the minimum TP10 (2003) specification of 12.5 mm/hr. Two cells had parts that were above and below the specification, and two cells had no recorded areas above 12.5 mm/hr. Note that the vertical axis has a logarithmic scale.

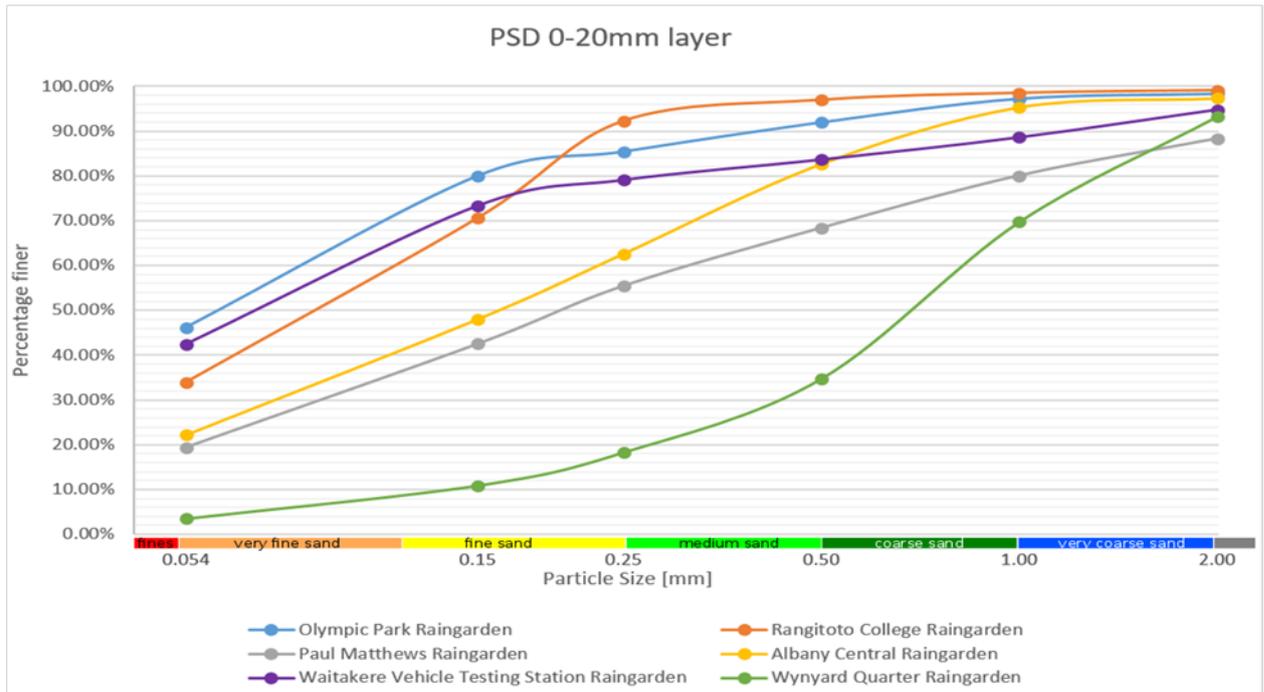
Figure 2: Particle size distribution of the top layer (0-20 mm)

Figures 2 and 3 show the particle size distribution curves of the top layer and the filter media. The relatively fine media (e.g. Olympic Park) is positioned higher in the curve, whereas the coarser media are found below (e.g. Wynyard Quarter).

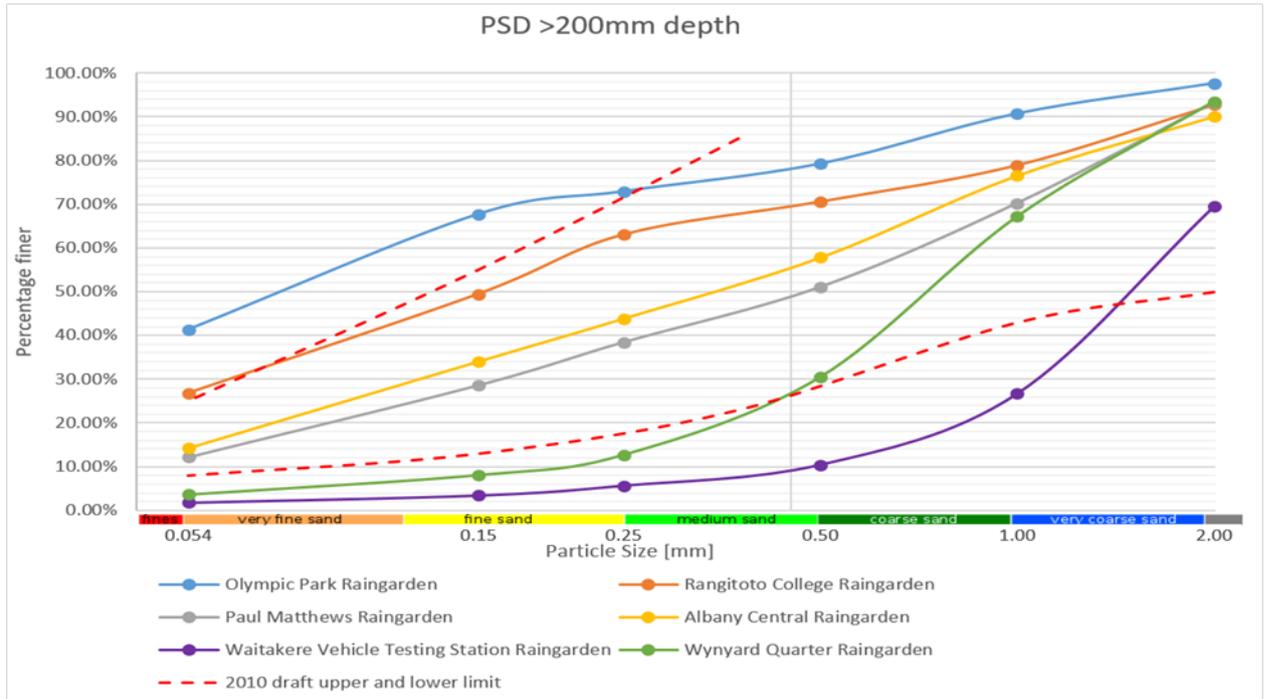
Figure 3: Particle size distribution of the filter media layer (>200 mm)

With 41% fines in the filter media, it is questionable whether the Olympic Park cell met TP10 requirements for clay content (<25%) during construction, and if it did, whether it could meet the 12.5 mm/hr permeability requirements. A double ring was inserted at 200 mm depth to compare to surface infiltration. After 40 minutes, no infiltration was observed, after which the experiment was stopped. Landcare Research provided data indicating that silt+clay weight percentage of the filter media was 60% shortly after establishment, having 22% clay. This does pose a question in terms of restorative approaches, as the filter media may be entirely unsuitable for bioretention purposes.

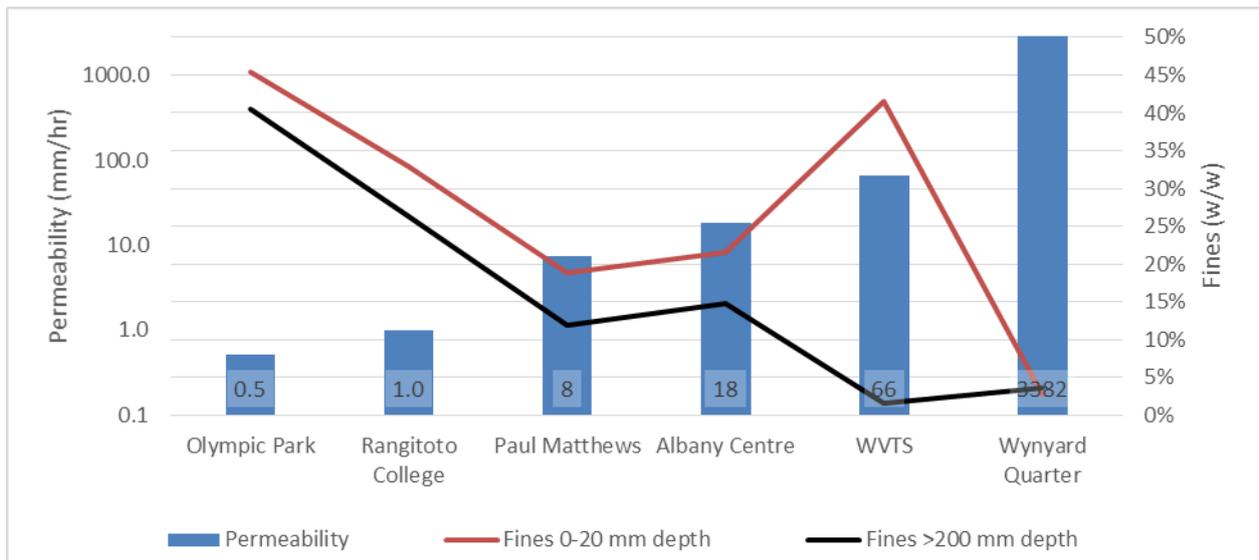
Figure 4: Permeability versus the weight percentage of fines at 0-20 mm and >200 mm depth. Fines (silt and clay) are defined as particles passing through 0.054 mm (54 μ m) sieve.

Figure 4 shows the content of fine particles in the top layer (0-20 mm depth) and filter media layer (>200 mm depth). As expected, the top layer had a higher content of fines, due to the inflow of sediments. Wynyard Quarter has a very low proportion of fines in both sediment and underlying media. Lower content of fines in the filter media generally corresponded with higher permeability.

The particle size distribution does include some permeability indicators and feedback for field observations. The weight percentage of fines in the 0-20 mm layer is strongly inversely correlated with permeability ($r = -0.75$). The two BRCs with the coarsest >200 mm layer are also the two with the highest permeability. However, the top layer at WVTs is likely to be restricting the flow, having over 40% fines in the 0-20 mm layer. Earlier research found that the filter media below the top layer has a permeability of 2000 mm/hr (Skeen et al. 2010). It is argued that the abundance of coarse roots in the upper layer results in that the permeability is still satisfactory and no further clogging over time is observed.

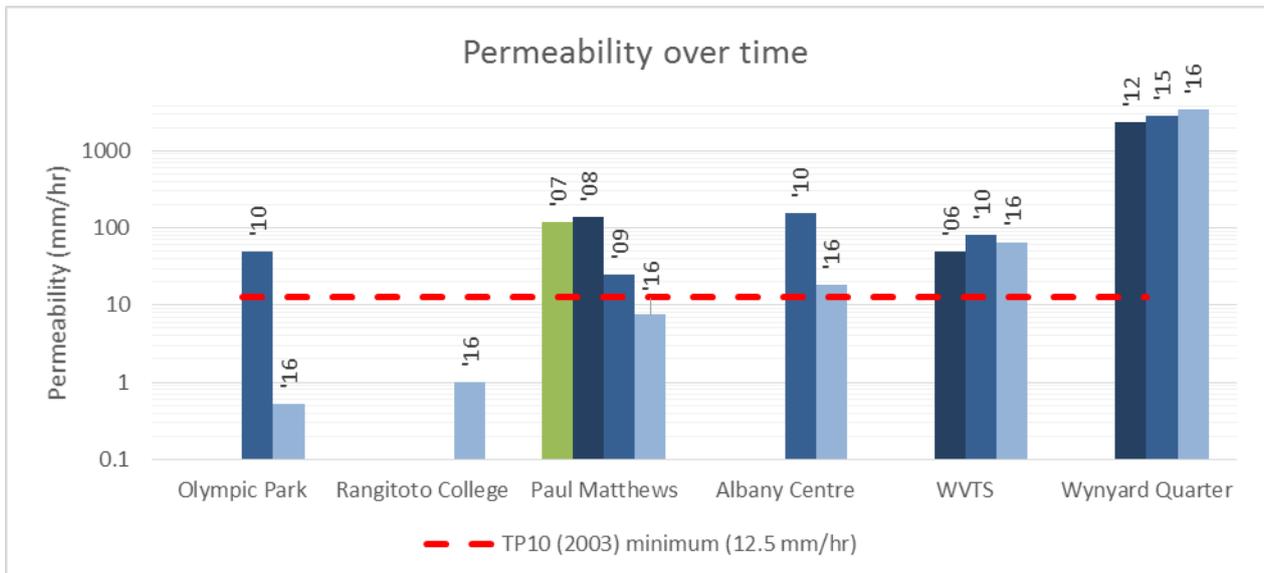
Figure 5: Change in permeability over time. Wynyard Quarter '12 and '15 data are minimum infiltration rates (mm/hr), closely resembling permeability.

As observed from Figure 5, three BRCs show a clear decrease in permeability over time, whereas the WVTS and Wynyard Quarter BRCs shows a stable permeability. Three BRCs do not meet the suggested TP10 minimum of 12.5 mm/hr; four do not meet the suggested North Shore City Council guideline permeability of 50 mm/hr. Note that the 50 mm/hr value came into force in 2008 and therefore does not operate retroactively on BRCs established prior to its release.

The case of WVTS, being the oldest of the BRCs, shows that increasing age is not necessarily connected with a decrease in permeability in the long term. The data shows that the permeability has been between 50 and 100 mm/hr for over a decade. The BRCs at Wynyard Quarter increased in permeability since their establishment, probably linked to vegetation development and little inflow of sediment (Simcock & Fassman-Beck 2016).

Over 6-7 years, permeability has decreased sharply at the Paul Matthews, Albany Centre, and Olympic Park BRCs. With a K_{fs} of 8 mm/hr, and 18% of the cell area practically impermeable, the performance of the Paul Matthews BRC is well below its 50 mm/hr target. The first of three sequential cells at Olympic Park has prolonged periods of ponding, with 39% of the total cell effectively non-functional, and the two following cells having an average K_{fs} of 0.5 mm/hr.
