New Zealand Transport Agency

SH58 Stormwater Treatment Trial of Catchpit Filter Systems

November 2008

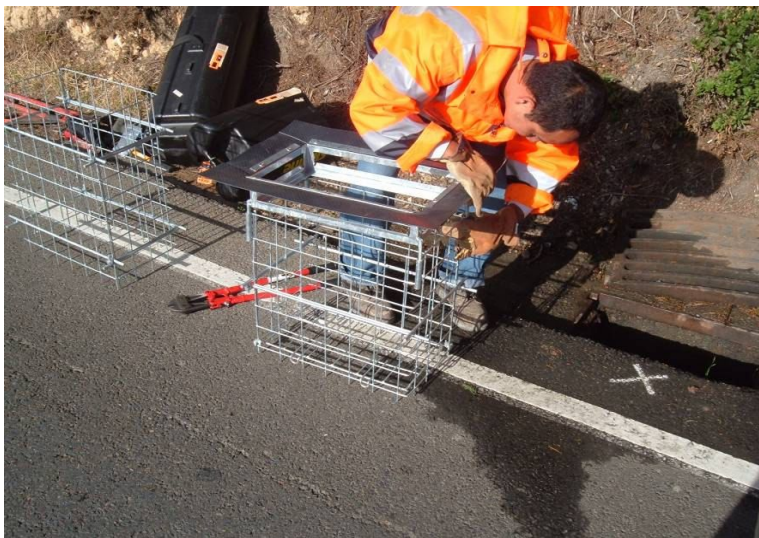
- The cage was then cut down to the appropriate length using wire cutters. (Note: this length of the cage is equal to the depth of the sump minus 200mm, but can be cut to fit as appropriate);

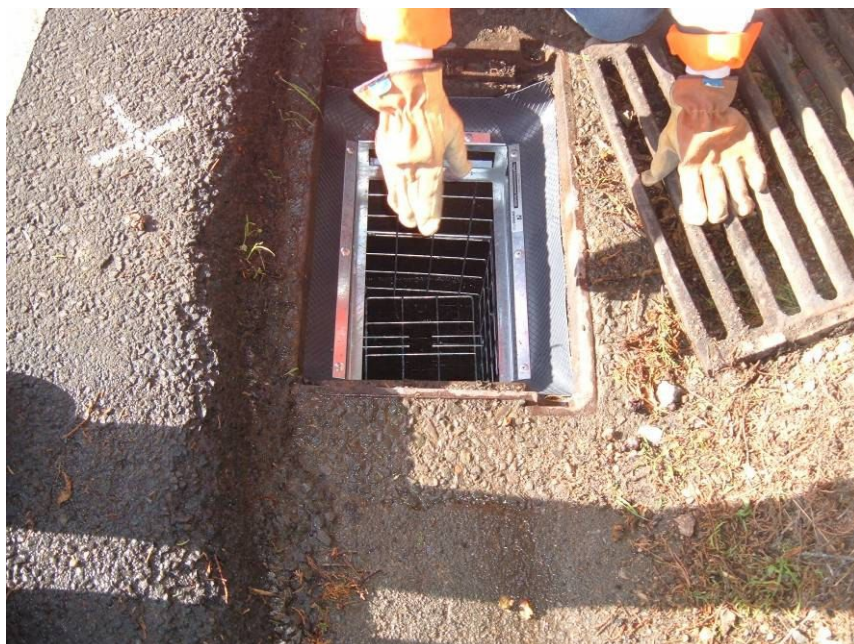
- A removable base made of the same material as the cage was inserted into the cage;
- The deflector panel (rectangular frame with plastic flaps) was then cut to size with a Stanley knife which involved cutting off excess plastic to fit the dimensions of the sump;
- The deflector panel was then placed onto the cage using allocated slots found at the top of the cage;
- The cage was then placed into the sump;

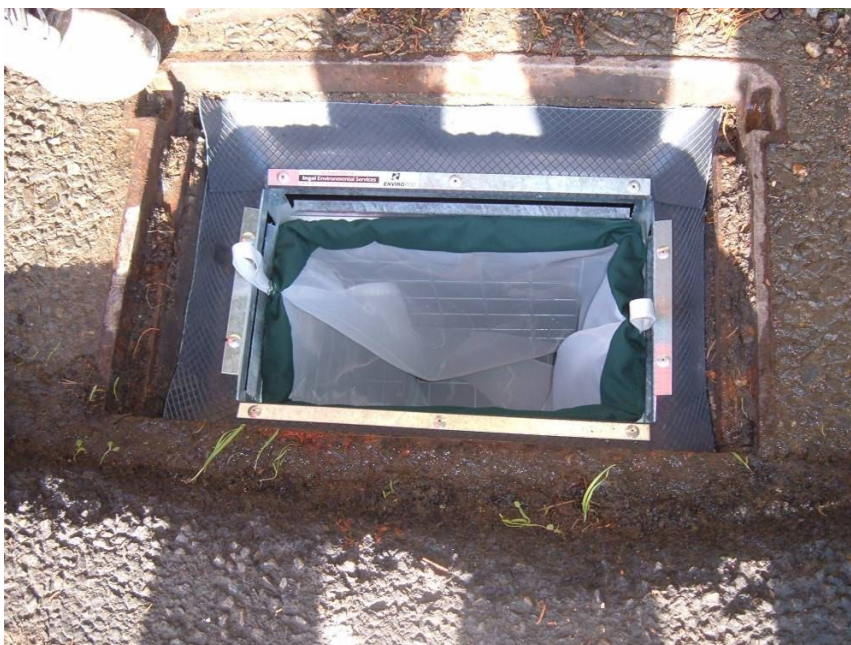
- The Enviropod filter bag was then threaded onto an aluminium ring, the tabs at the side of the bag were turned inside the bag and the bag and ring were seated onto a ledge on the inside of the deflector panel.

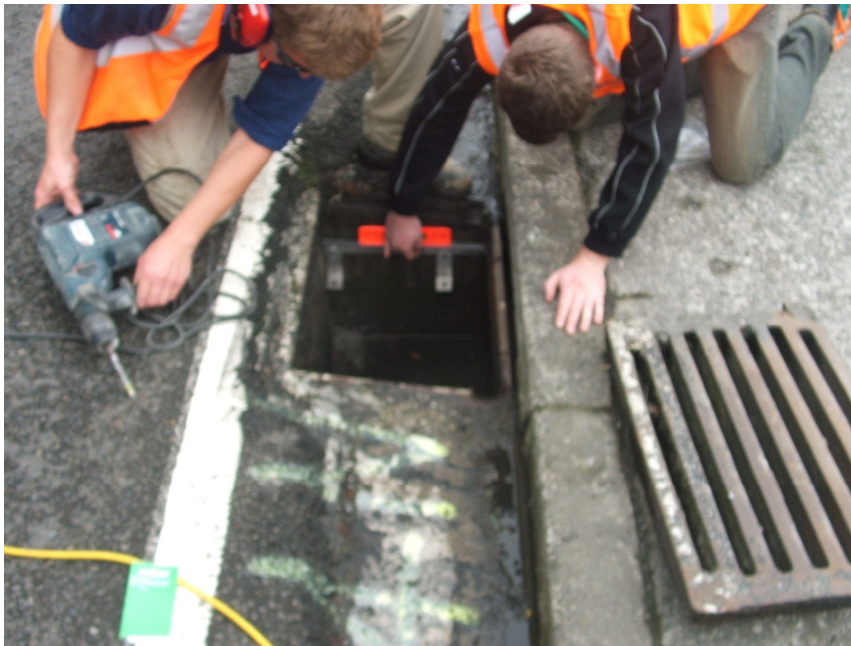
- Two holes at the same level were drilled into the two shorter sides of the sump wall using a hammer drill and generator;
- An aluminium bracket was then secured to each wall with 8mm nylon anchors;

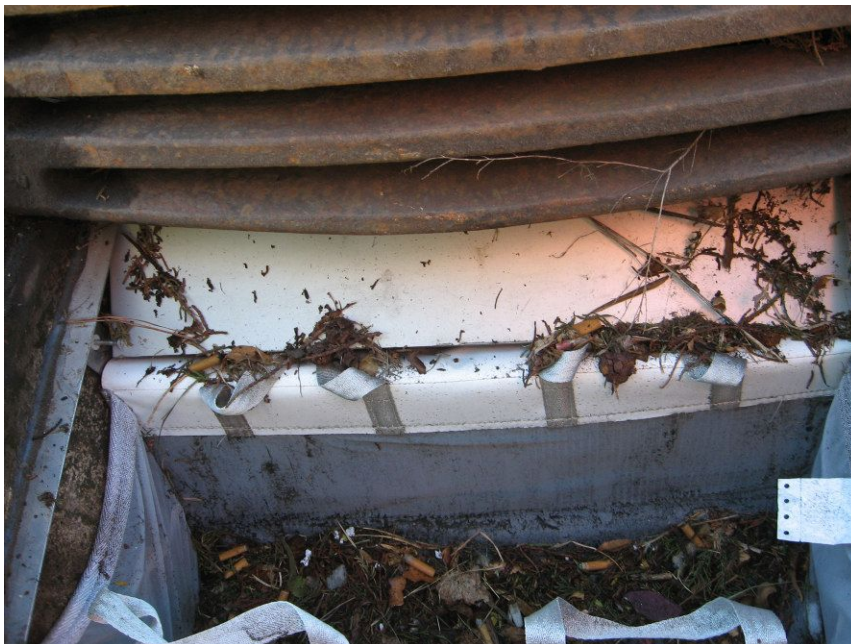
Installation of the CFS in S4N was initially carried out incorrectly. The overflow flap was used to deflect water that comes into the sump through the backflow opening into the filter. This flap was jammed open with debris from road runoff and meant that any runoff that entered the sump through the backflow opening bypassed the catchpit filter.

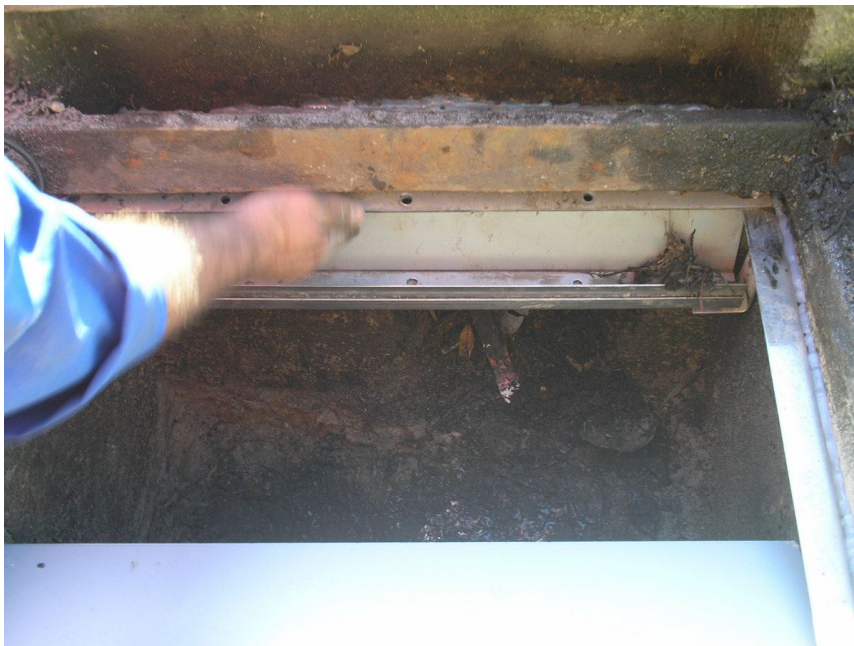
- The entire CFS that was in place was taken out;
- A further two holes at the same level were drilled into the two shorter sides of the sump wall;
- An aluminium bracket was then secured as previously with 8mm nylon anchors, with longer brackets fixed to this aluminium bracket on the shorter side of the sump;
- The same overflow flap that was shaped to fit the area of the sump below the backflow opening was used in the new installation;

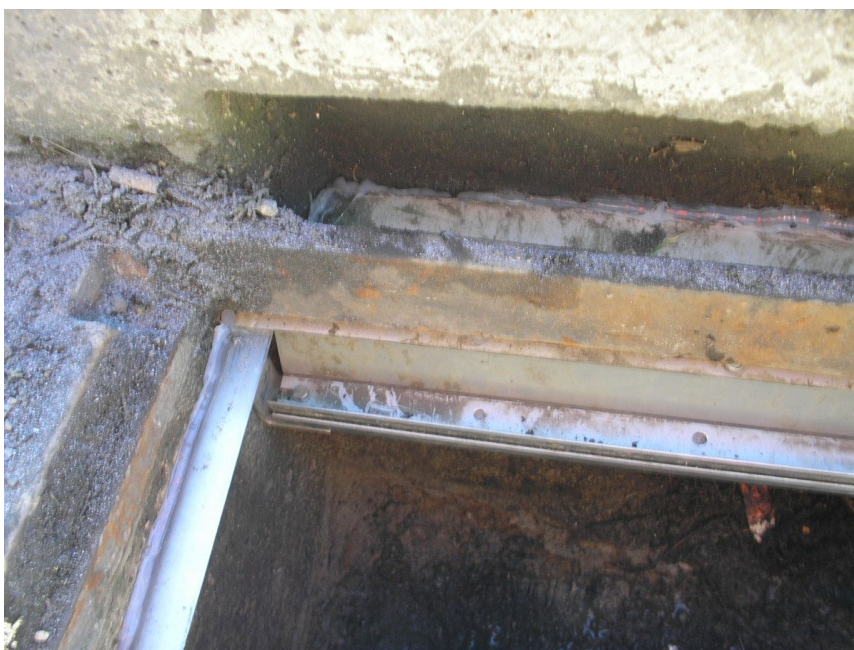
- This fixed flap was bolted to the top of the bracket along the north side of the sump;

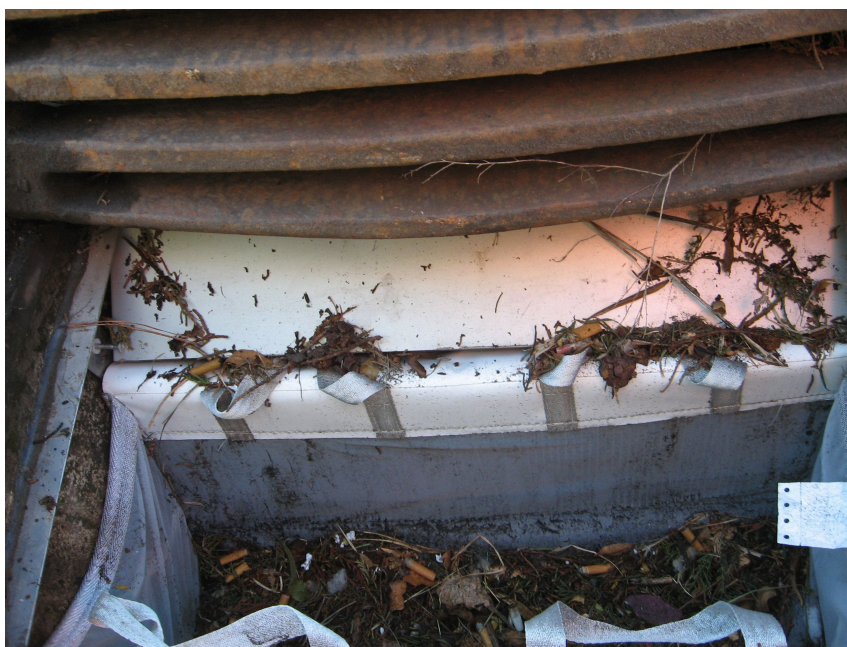
- S1: The deflector panel had come away from the sump wall on the southern side of the sump as shown below. The sump was full of water up to the invert of the outlet pipe and there were signs of overflow from the CFS.
- S4N: The filter appeared to be operating well. There was a relatively large amount of material in the filter bag although the amount was difficult to quantify. Some material was caught between the overflow flap and frame.

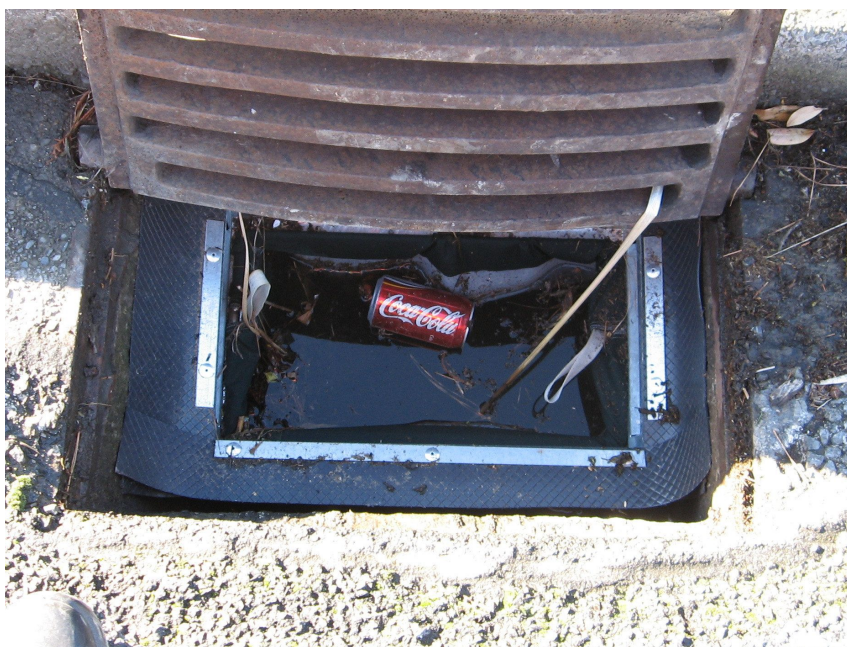
S1: The deflector panel had come away from the sump wall on the southern side of the sump, shown in the photo below.

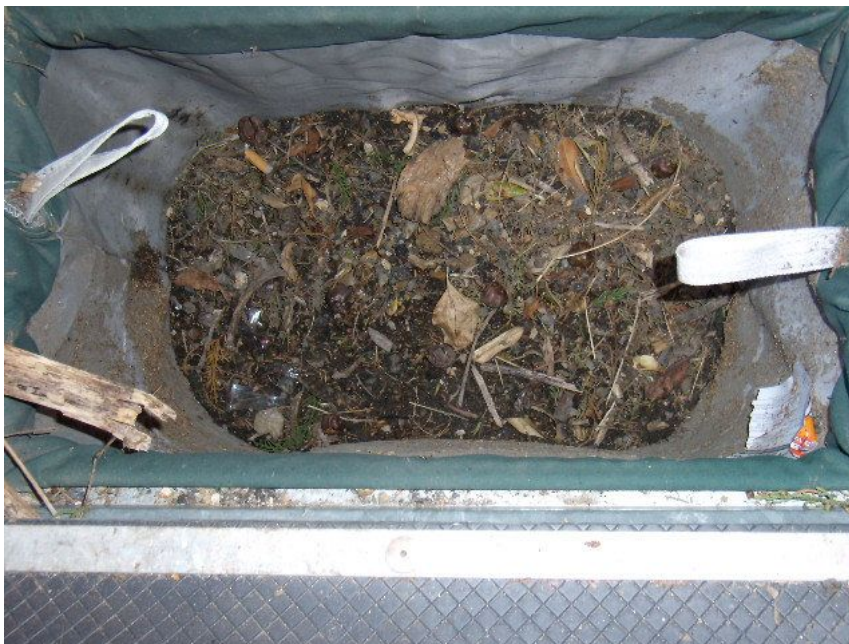
From the first maintenance inspection after three months (on 23/8/2007), the Enviropod filter bag at S4S contained approximately 25kg of debris comprising twigs, leaves, plastic and soil combined with water.

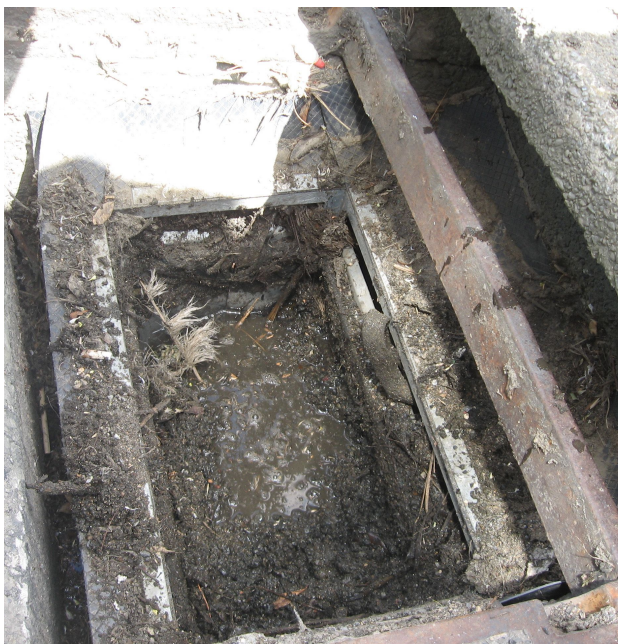
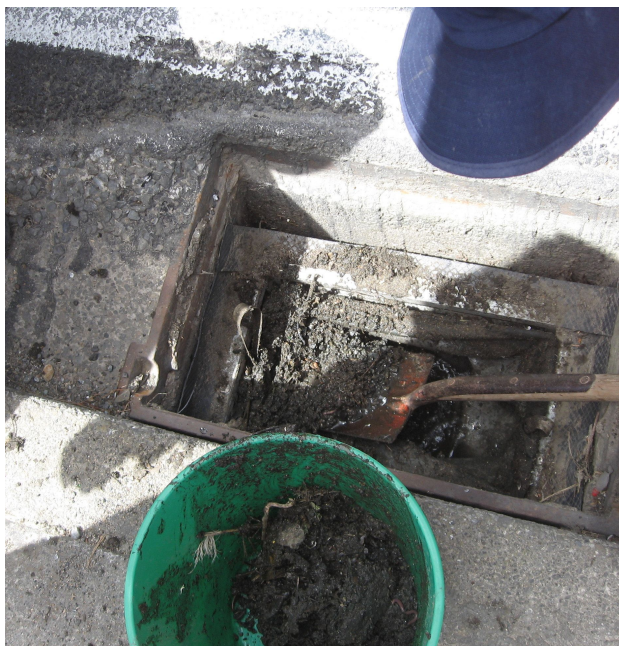
S1 underwent its first maintenance on 27 November 2007 (after 6 months use) and contained approximately 67kg of material. Prior to lifting the bag out some material had to be partially dug out of the filter bag to reduce the weight so the bag could be lifted out, a process which proved to be quite difficult. The extent of material and emptying process is shown in the two photographs below.

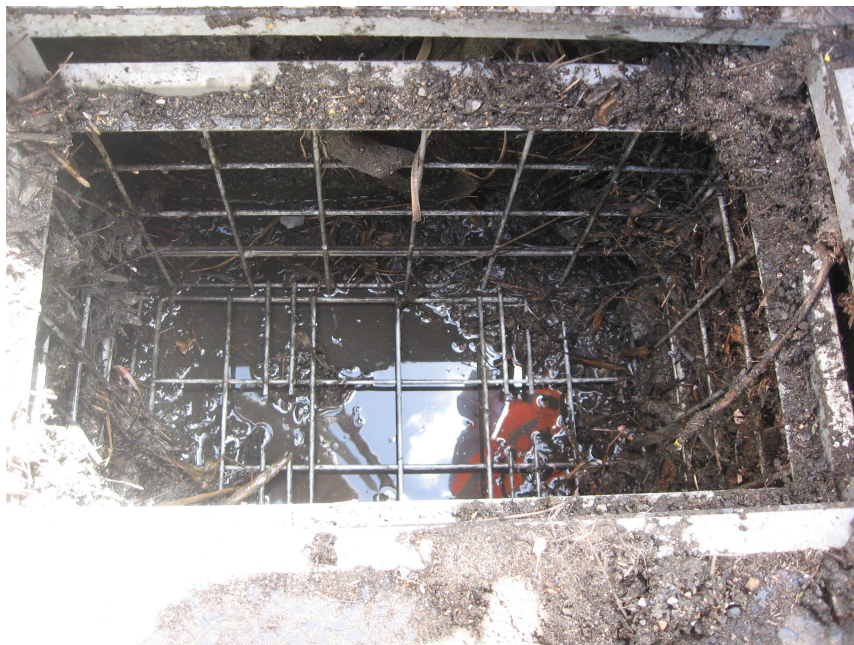
The photograph below shows evidence of a tear which may have occurred digging out material or ripping when lifting the bag out of the cage. As previously observed there were signs of overflowing and the filter bag being bypassed.

Regarding durability of the filter bags, apart from one Enviropod bag that was replaced and a tear in another bag (possibly caused during sampling), it appeared that Enviropod bags would have lasted the length of the trial. The Ecosol bags lasted the duration of the trial. Although not proven by the findings, and while the Ecosol bags did not have the same capacity as the Enviropod bags, it was felt that they would likely have a longer life and be slightly more robust due to the second 'oyster mesh' surround layer.

- Both bags appeared to be relatively robust apart from the tear in the Enviropod bag; however Ecosol bags do have a second layer and are slightly cheaper so there may be savings to be made if bags need to be replaced regularly.

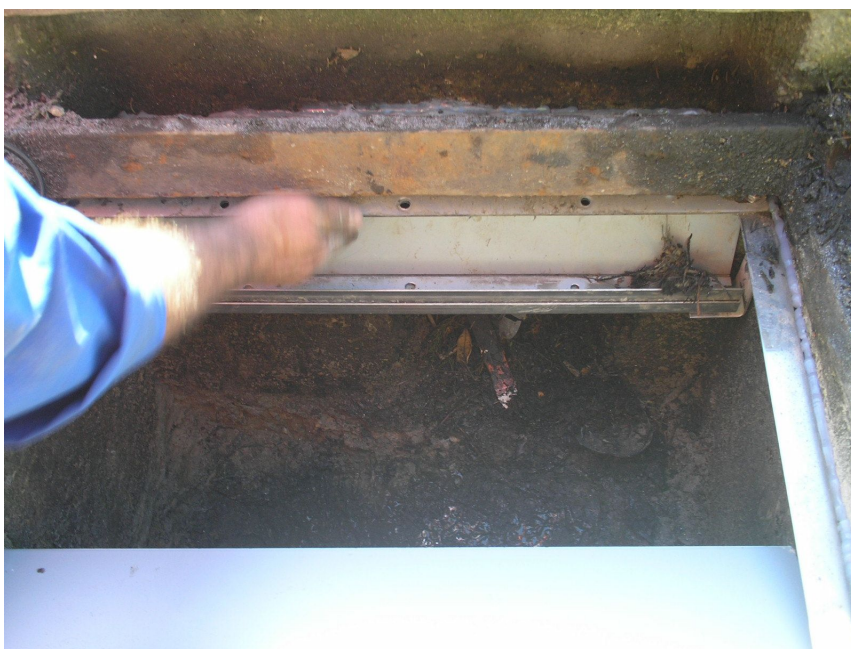
During the first maintenance inspection after three months (23/8/2007), the Ecosol filter bag at S4N was reinstalled due to the overflow flap being incorrectly installed. The presence of material in the bottom of the sump highlighted the effect that incorrect installation had on the working of the CFS. The build-up of material that had bypassed the filter in the base of the sump is shown on the photograph below

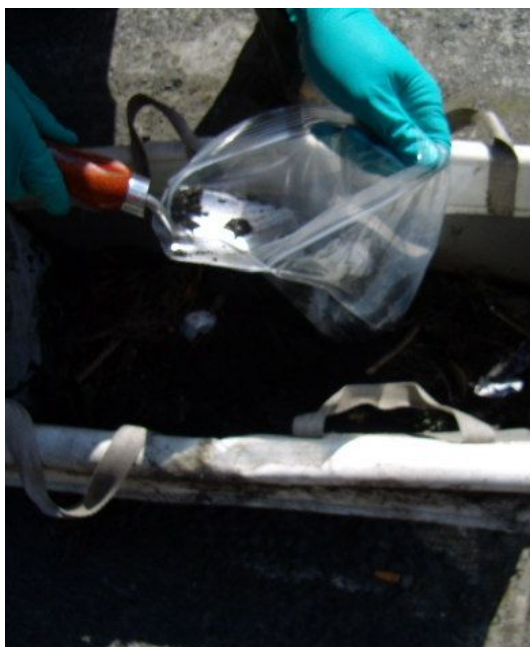
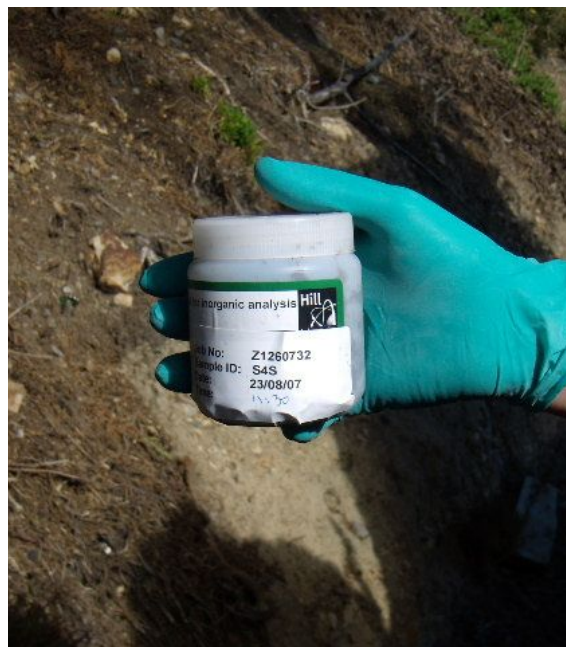
The approximate total retained wet sediment load was estimated at the end of each test period by weighing the CFS in the field using a calibrated spring balance. If the quantity of retained sediment was too large to weigh in one sample (e.g. greater than 40 kg) then the retained mass was weighed in discreet amounts.

Samples of retained material in the sump filter bags were collected on three occasions; September 2007, November 2007 and March 2008. During the first sampling event (September 2007), only two of the four filter bags were sampled (one Ecosol, one Enviropod and the control/comparative sump containing no filter bag). Two of the four filter bags were left unsampled so as to assess their performance over a six-month period.
