Enviropod E.T.S. Management Plan

Brisbane City Council Enviropod Trial

> August 2001 Issue B

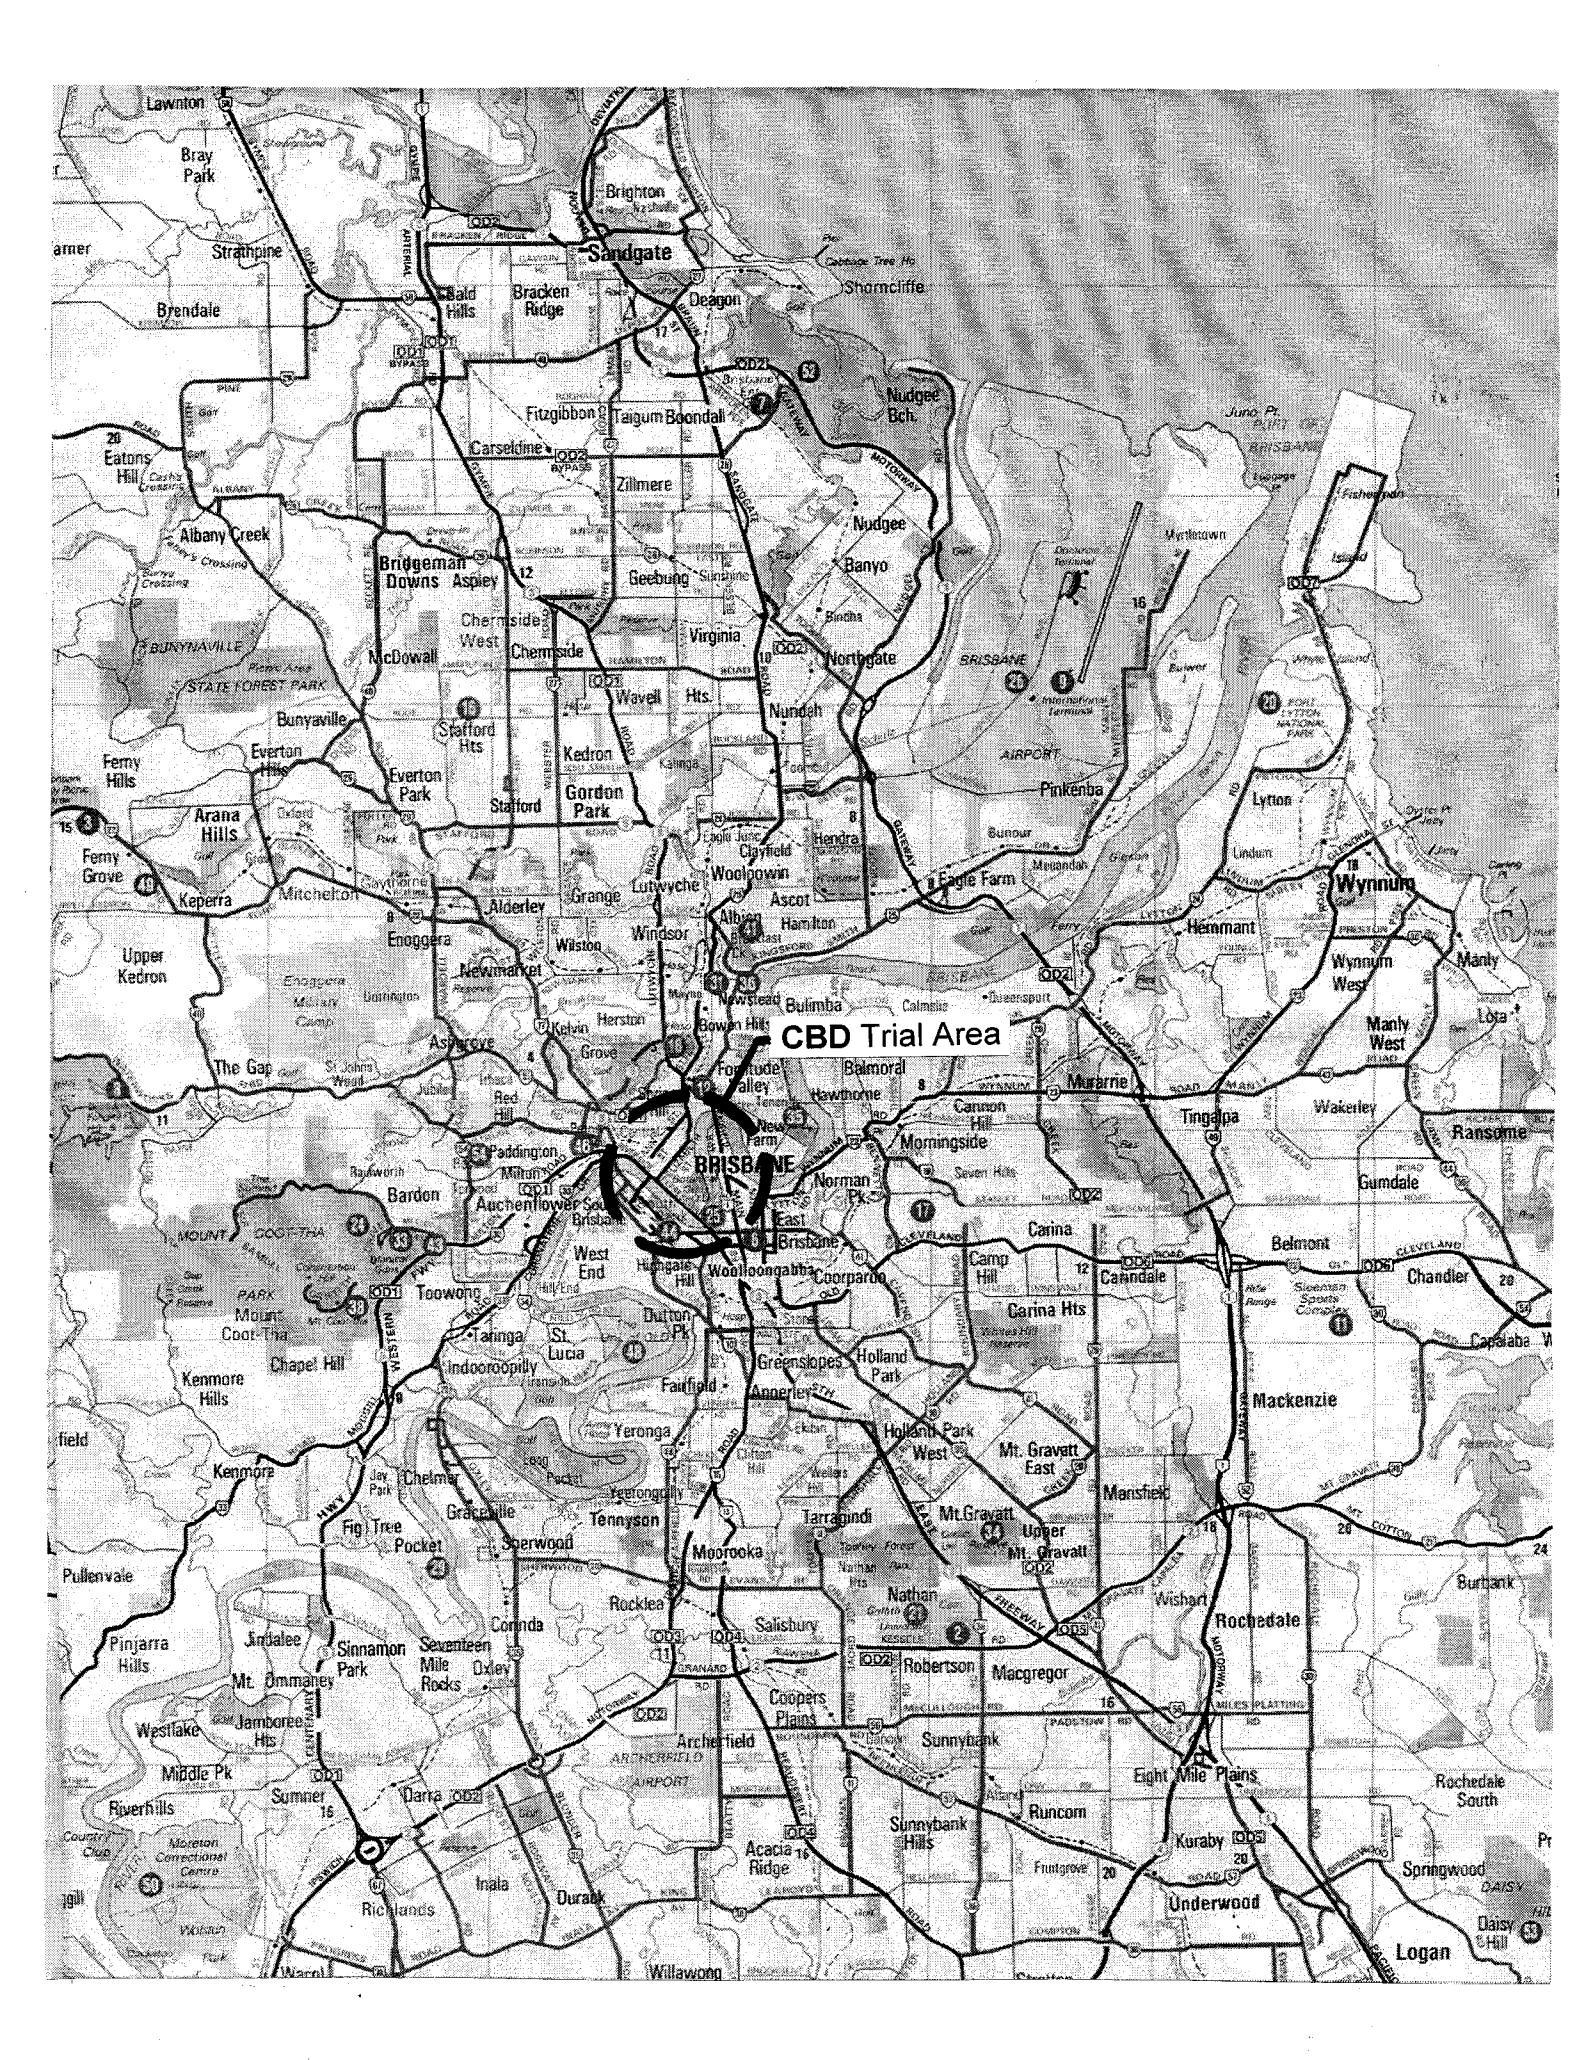
Brisbane CBD Site locality plan

The following report details the results of approximately 6 months monitoring of 155 Enviropod filters installed in selected gullypits within the Brisbane CBD (see Fig 1 Location Plan). The EnviropodTM filter is a gullypit insert, which comprises a supporting framework, overflow system and a replaceable filter, which is routinely serviced.

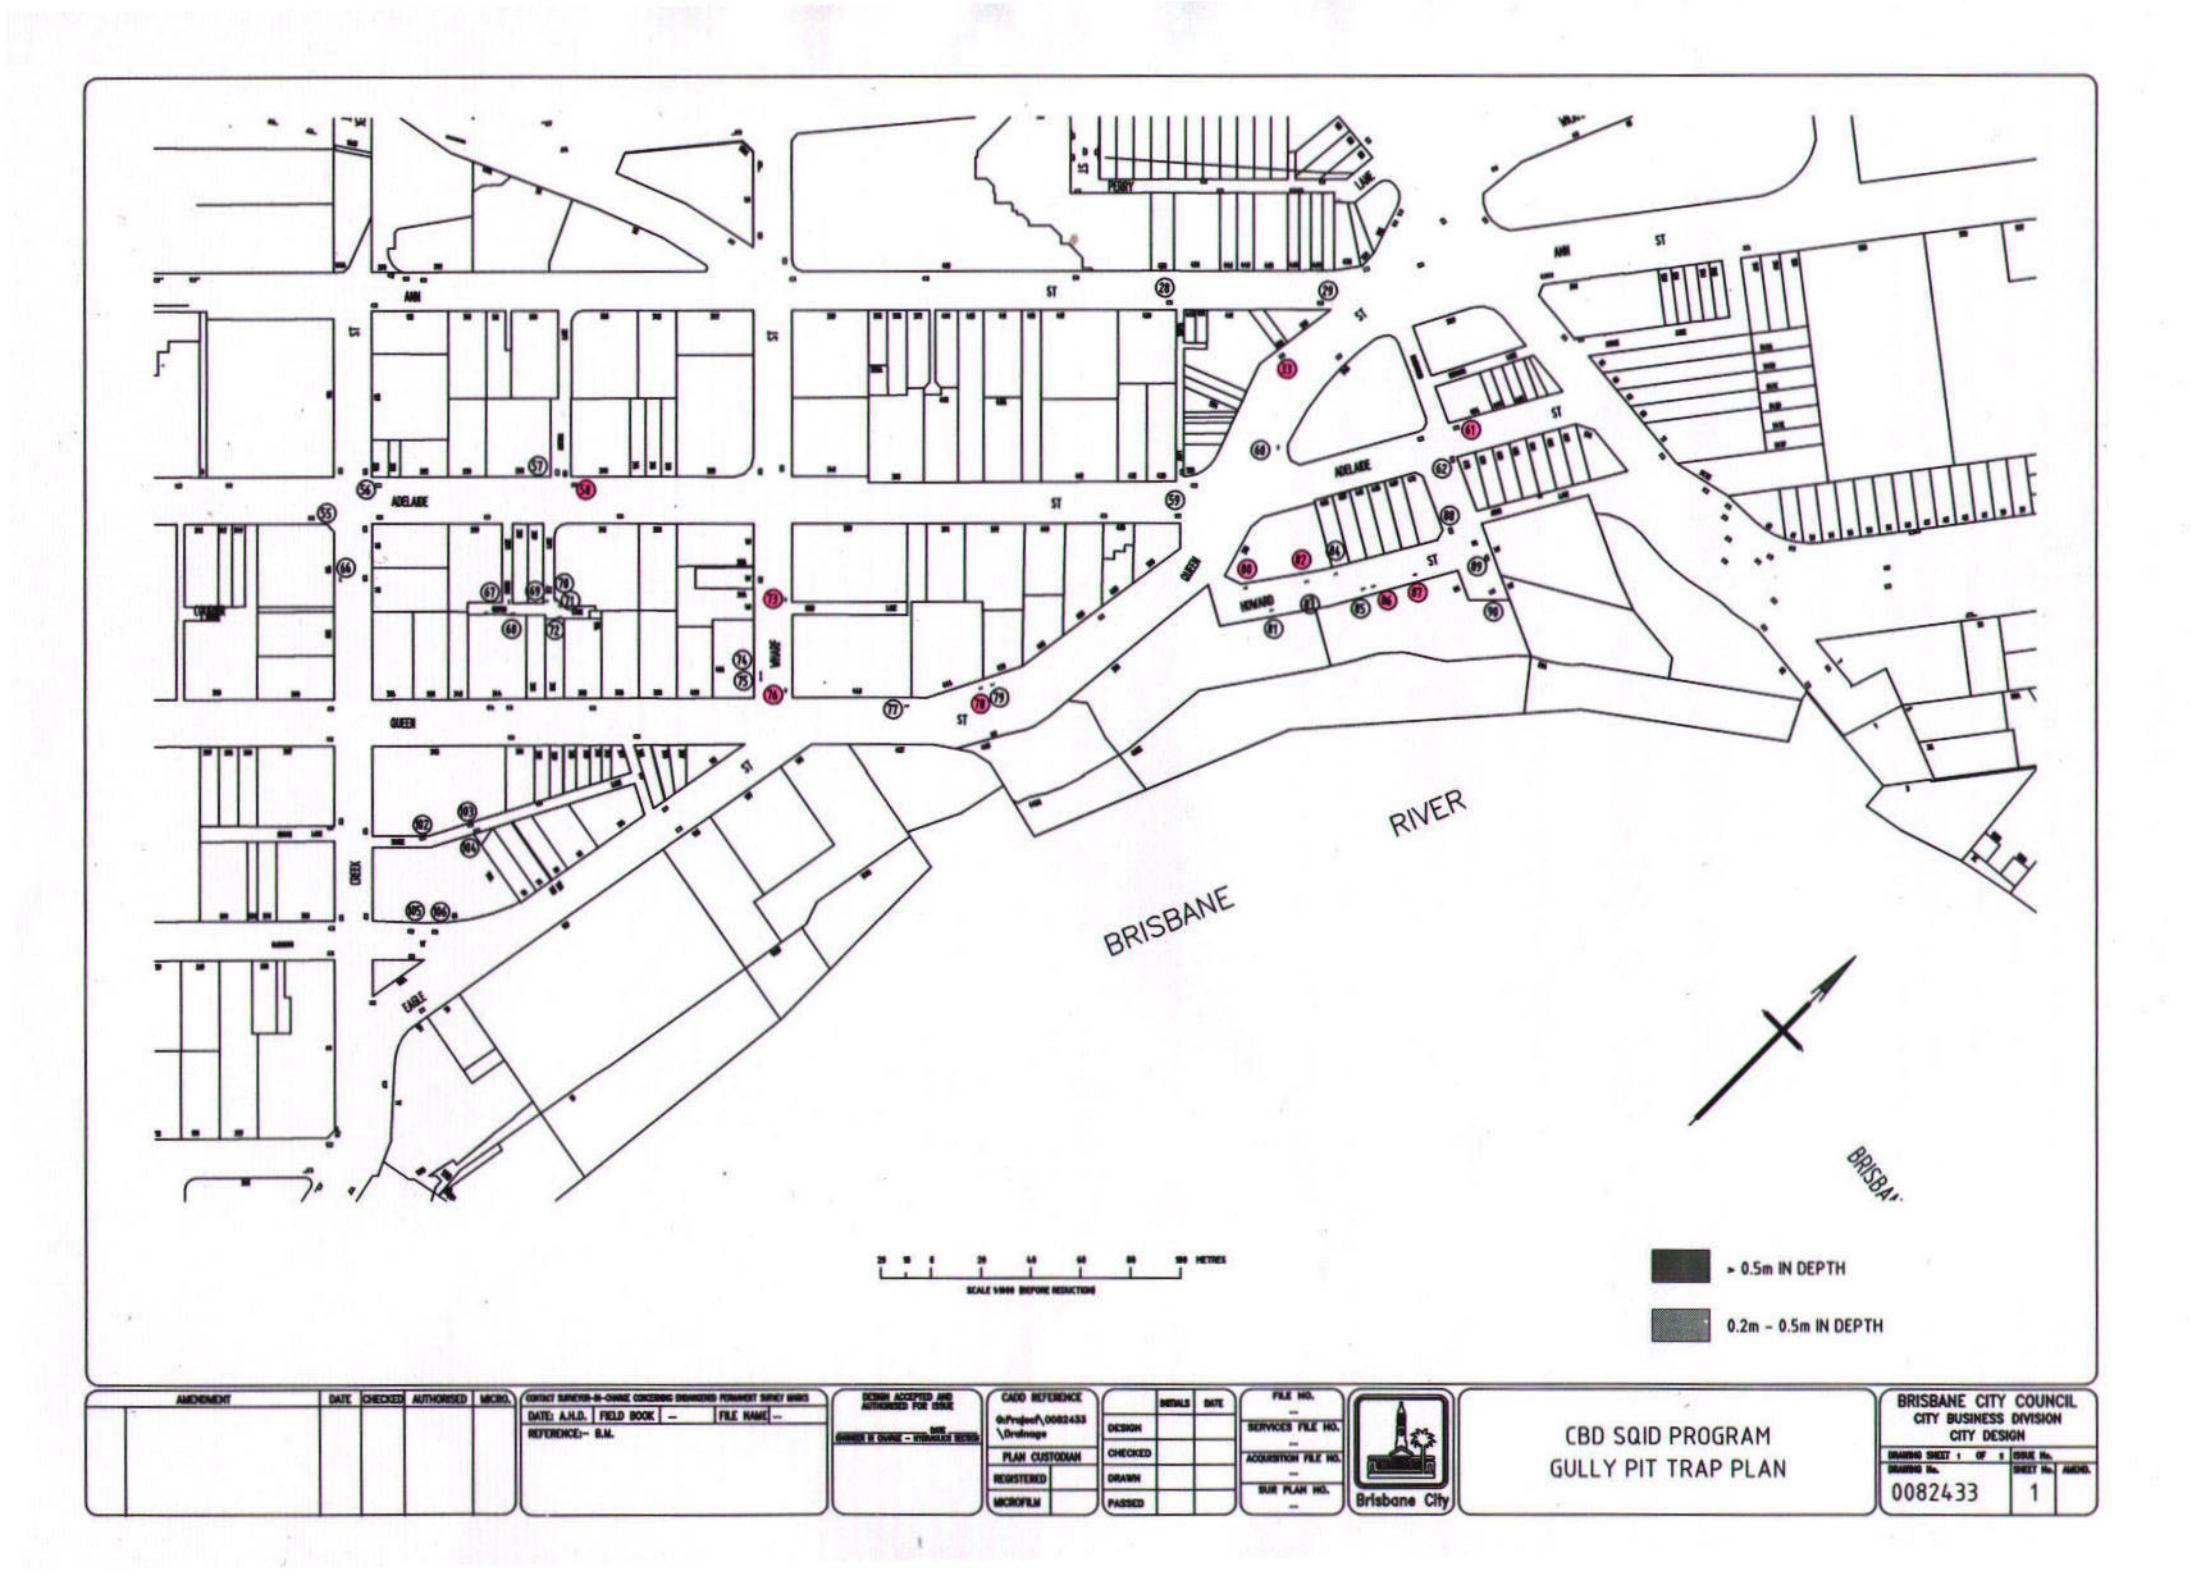
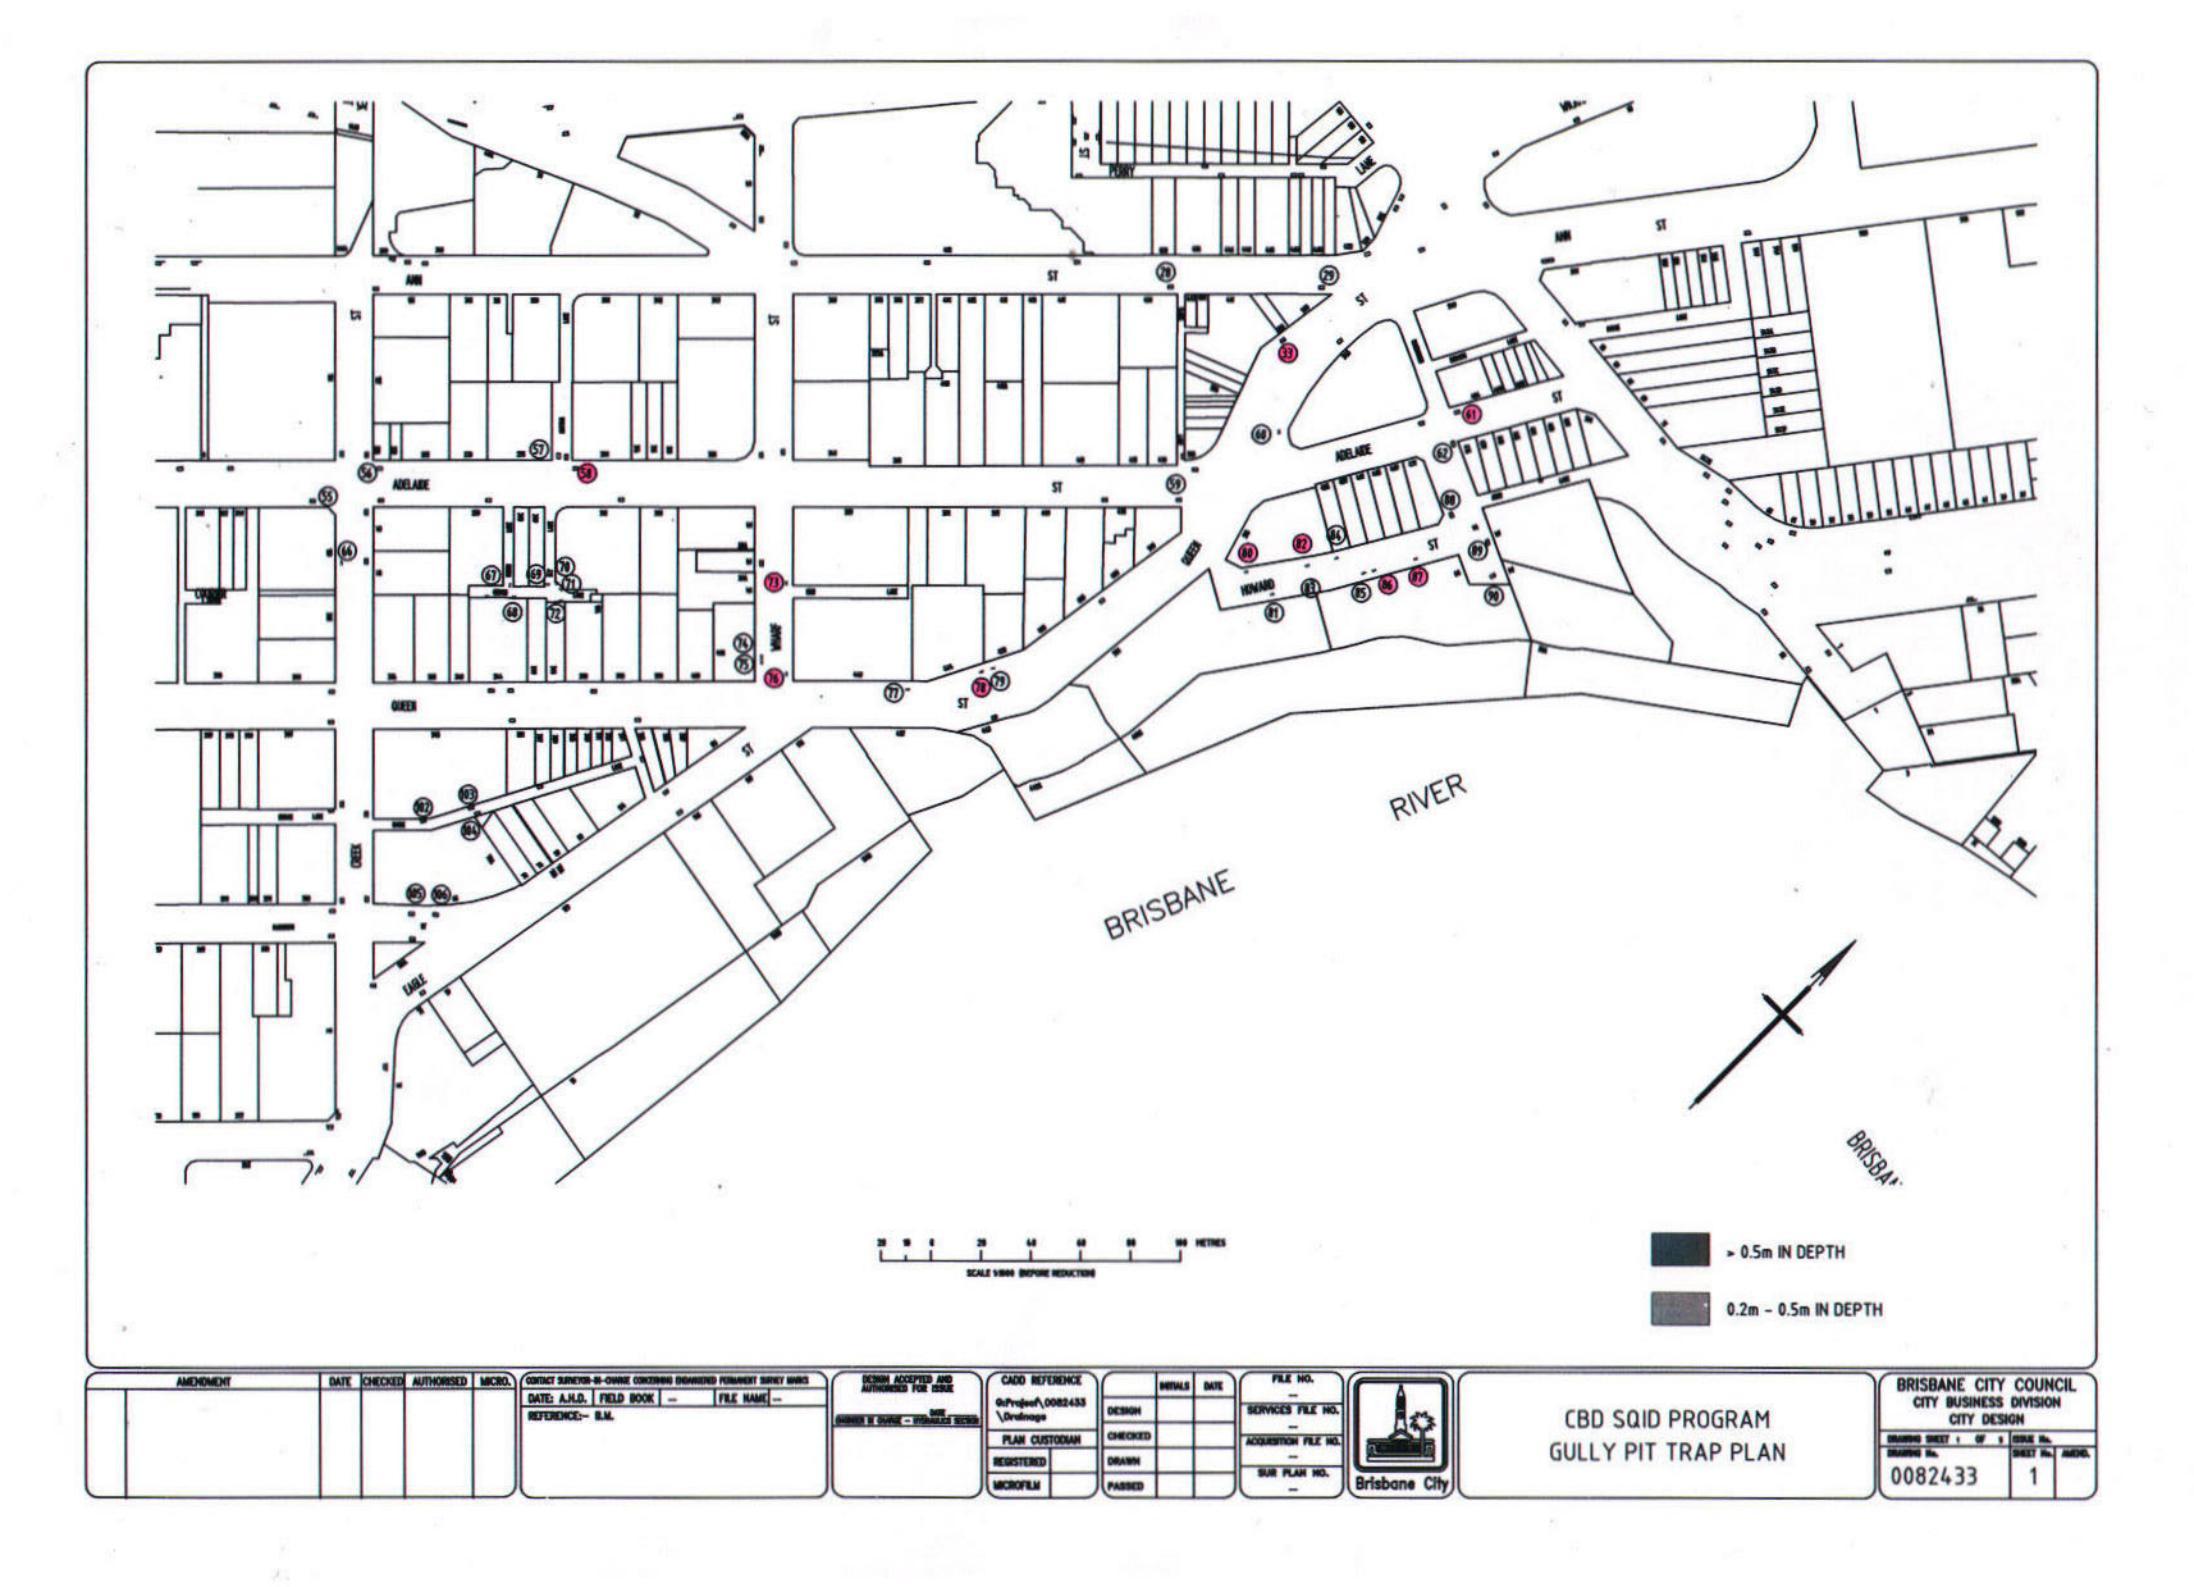
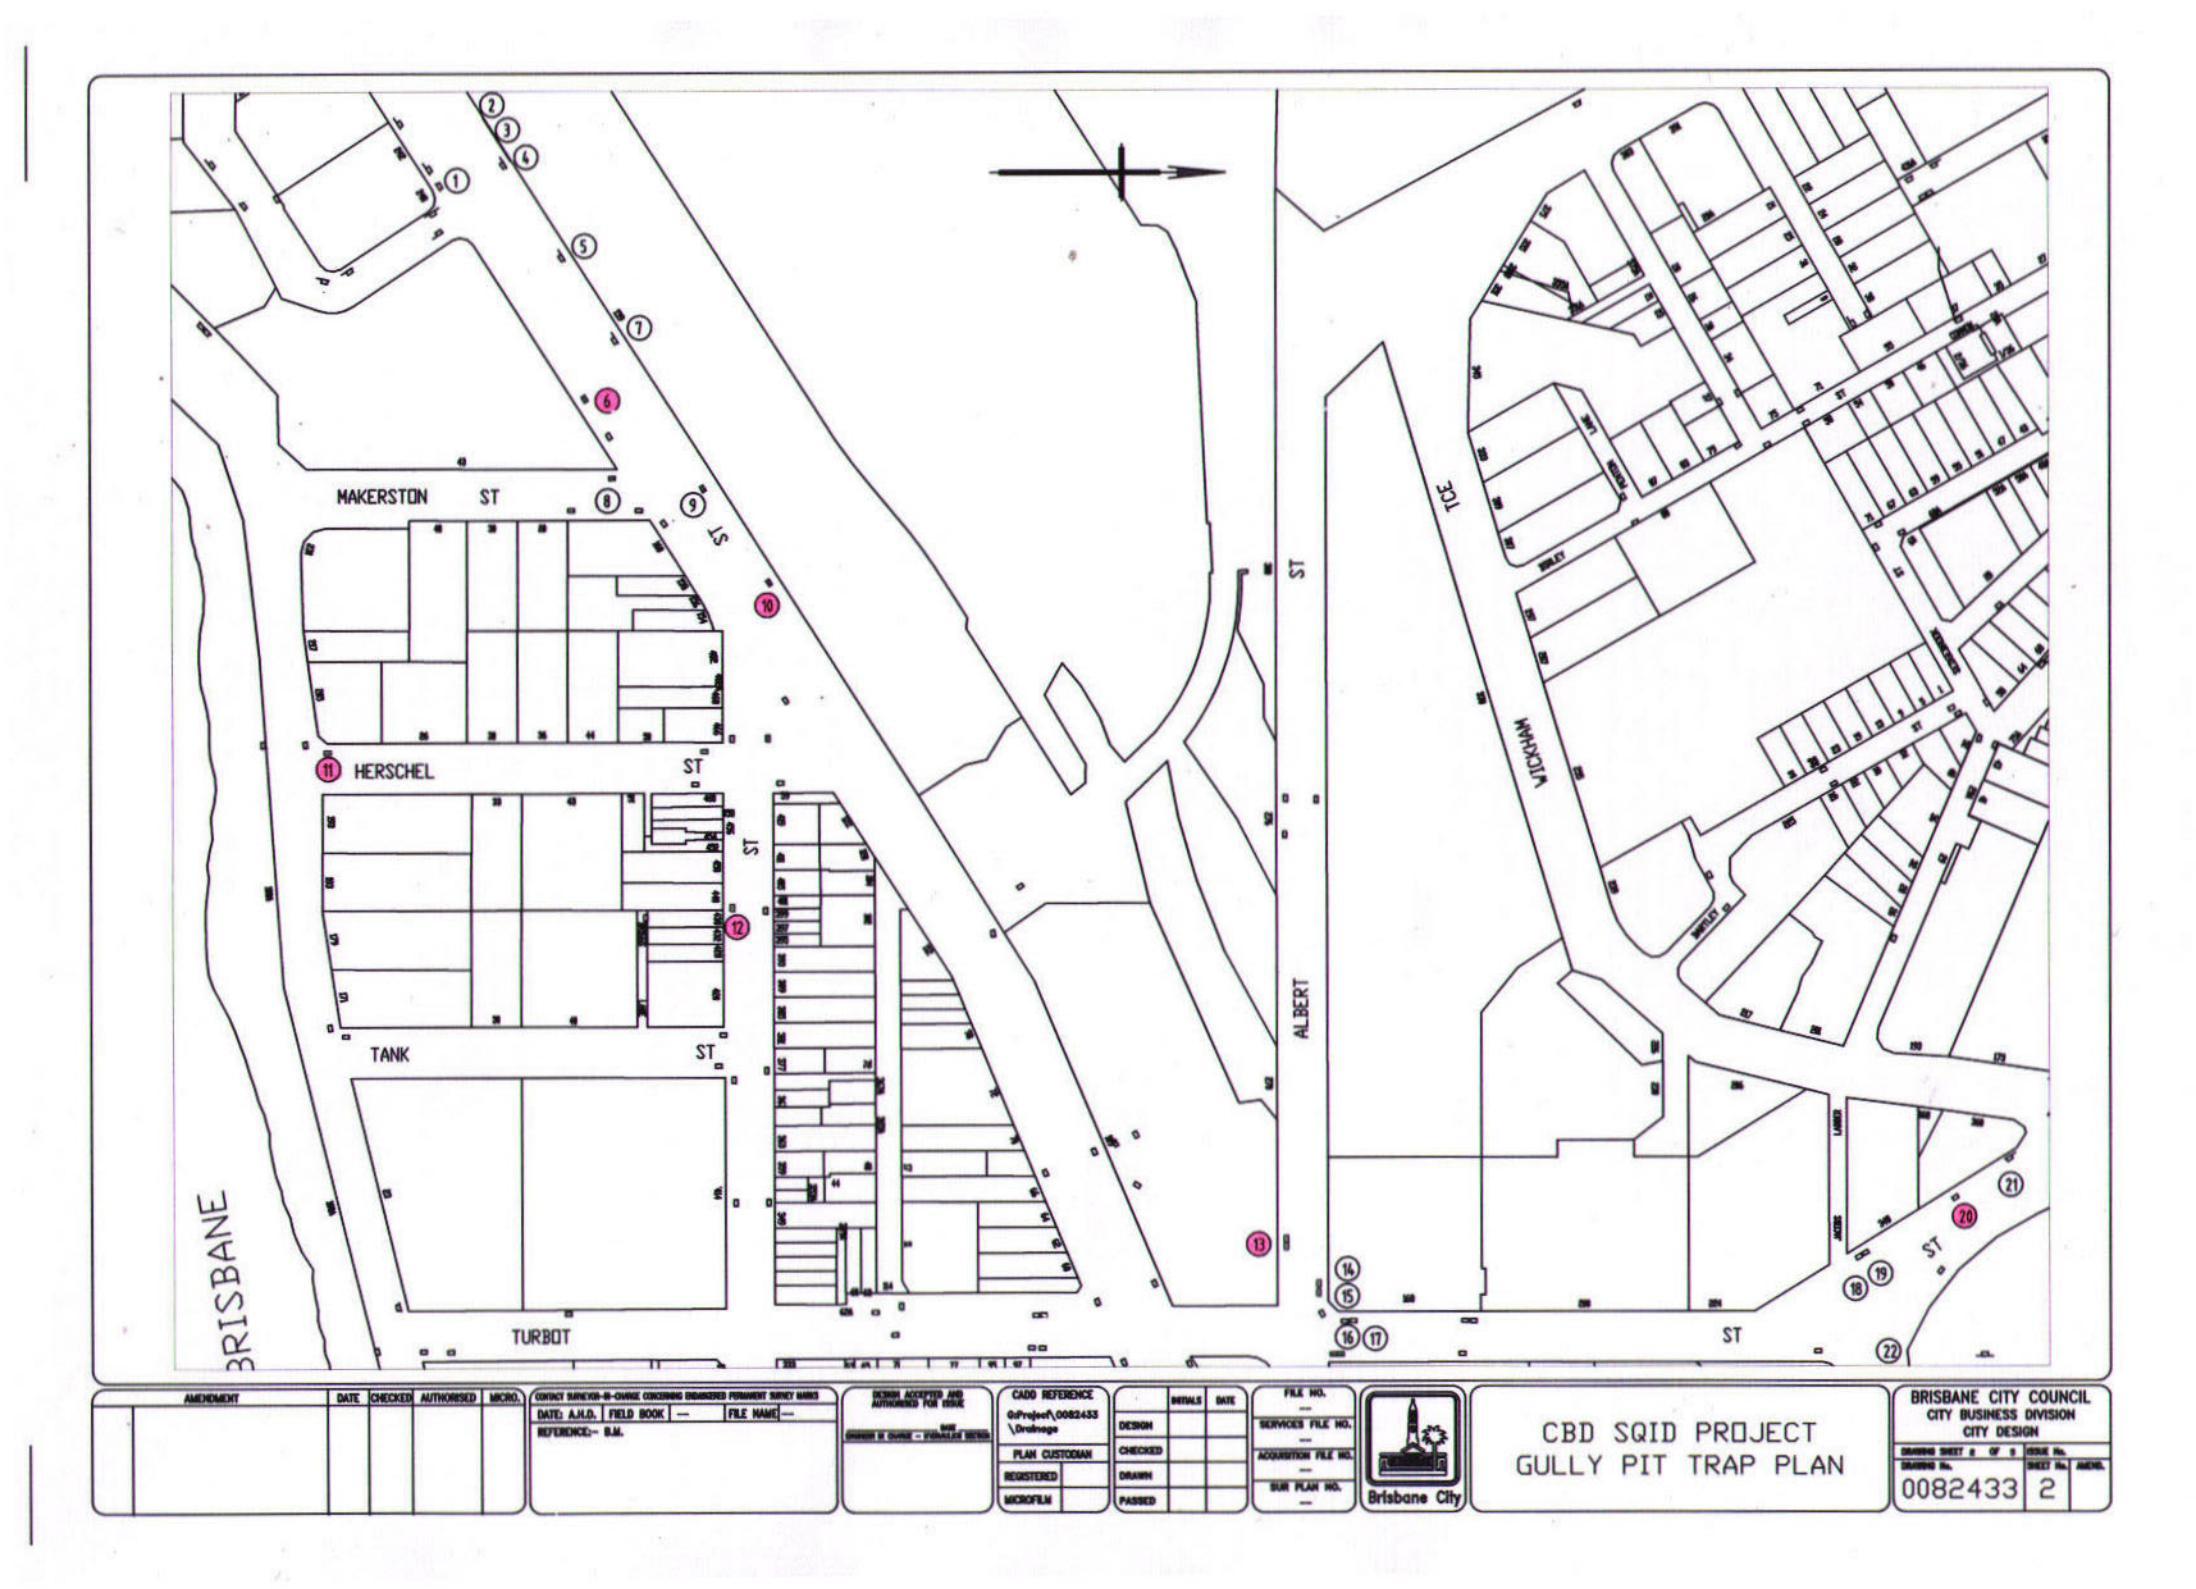
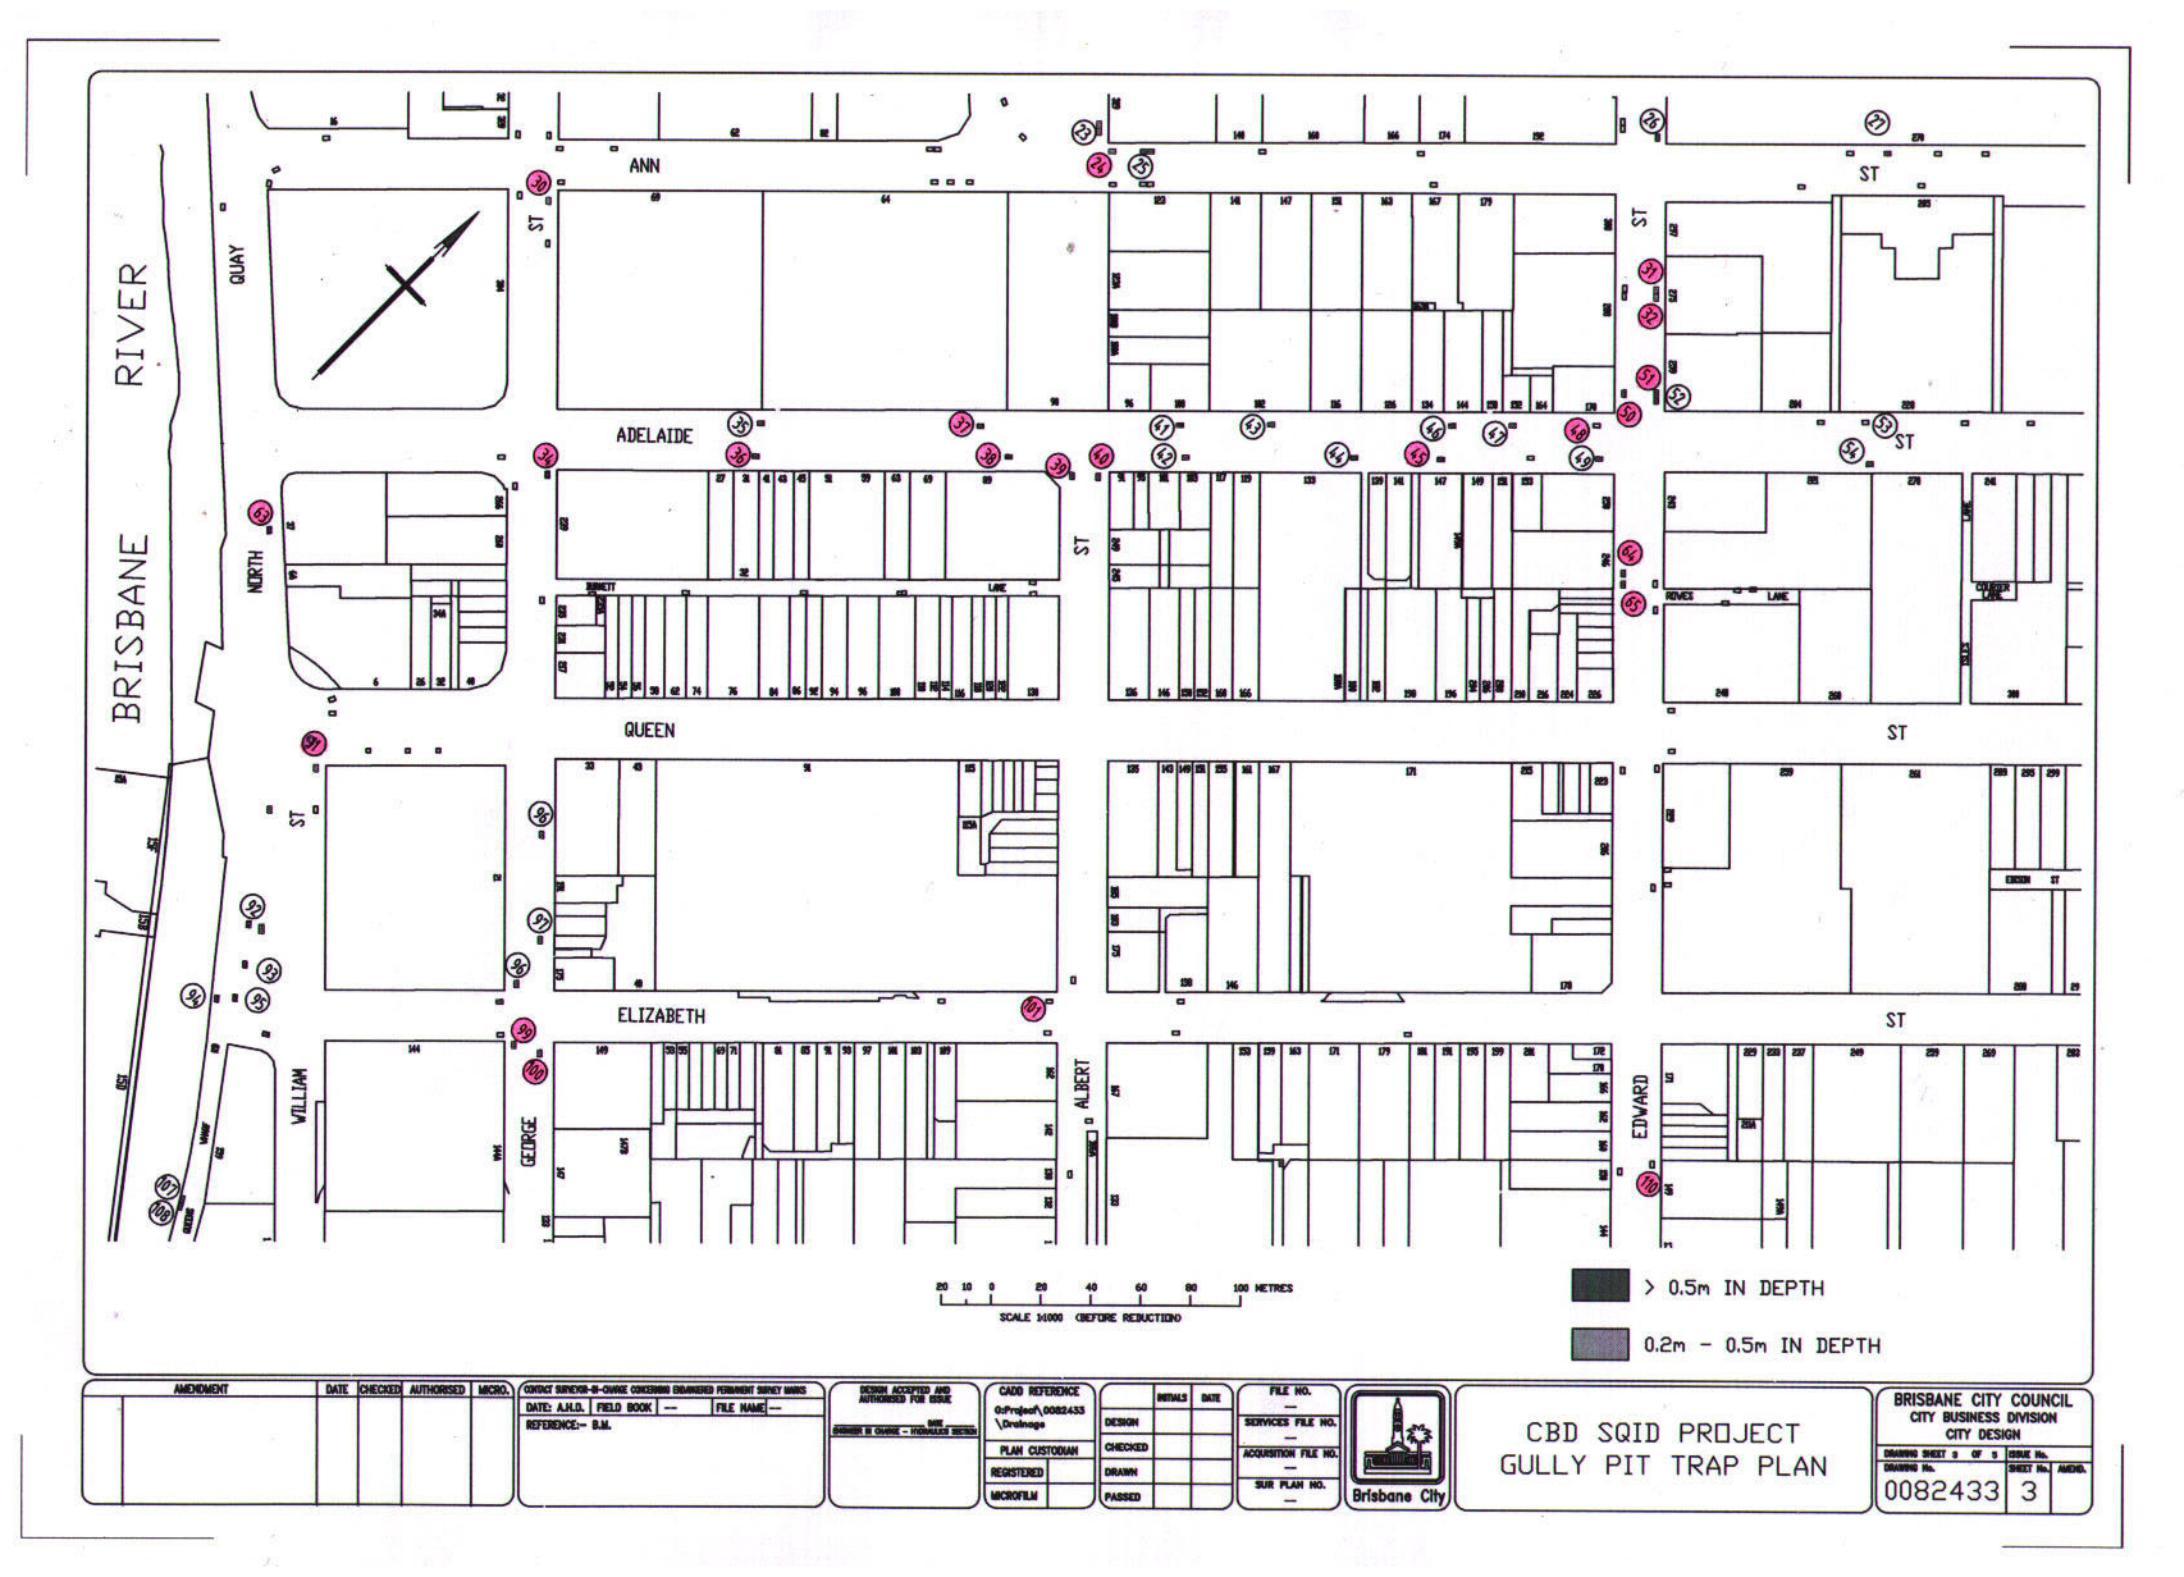
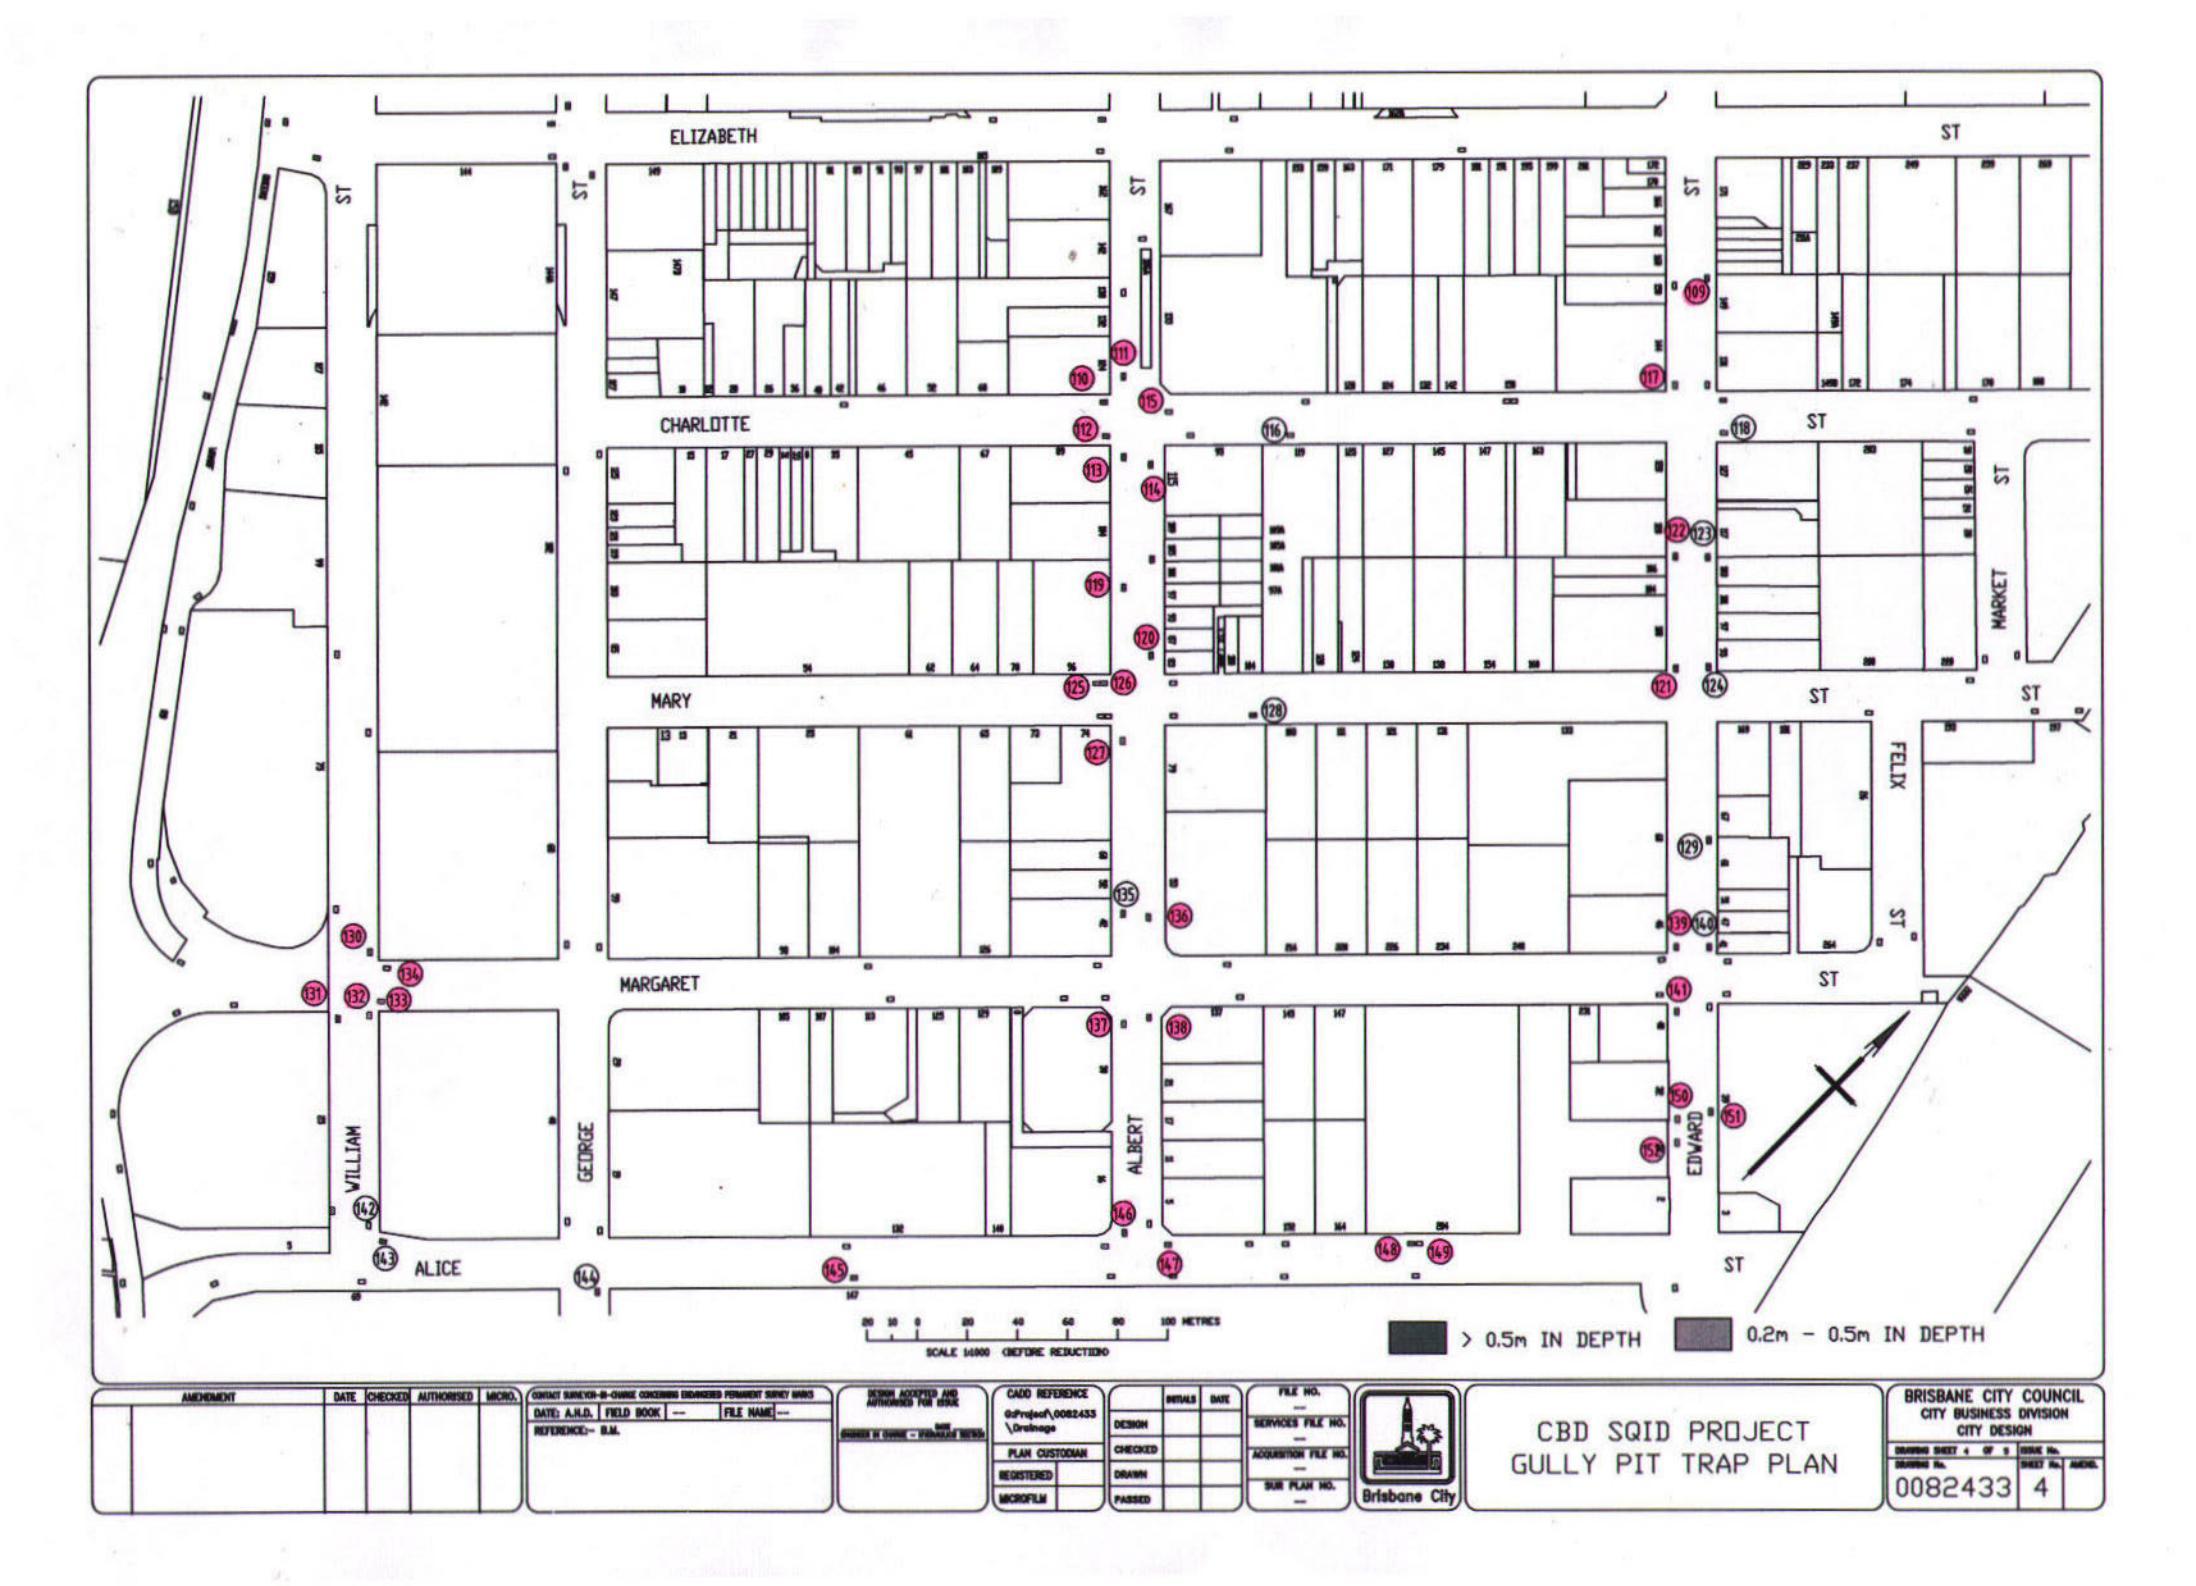
Appendix F Location Plans

The high loading (Hot Spot) Enviropods have been identified in the Site Plans. The following table lists the streets with a high number of hotspot pits. It is suggested that gullypits without Inserts on these streets be retrofitted.

- Enviropod Podmesh 200 Filters be installed in fine sediment "Hot Spot" locations.
- Streets identified as hot spot streets (see above) are completely retrofitted with inserts. These can be prioritised and implementation staged to suit budgetary requirements.
